TECH NOTE

HONDA ACCORD/LEGEND/MDX TIMING COVER MODIFICATION REQUIRED WITH REPLACEMENT OF BELT TENSIONER

BULLETIN: TSB005_AU

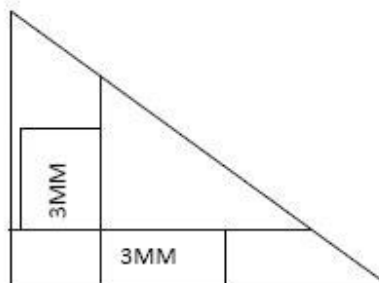
THIS AREA WILL NEED TO HAVE 3MM OF MATERIAL REMOVED

IMPROPER INSTALLATION MAY RESULT IN A DAMAGED FRONT TIMING BELT COVER AND IMPROPER ACCESSORY BELT TRACKING, EVENTUALLY LEADING TO BELT FAILURE!

The removal of approximately 3mm of plastic material from the lower timing belt cover is recommended prior to the installation of the updated accessory belt drive tensioner, allowing for proper clearance.
