TECH NOTE

AUTOMOTIVE – TIMING SYSTEM

INSTALLATION RECOMMENDATIONS FOR TIMING BELT SYSTEM ON HONDA 1.7L ENGINES

BULLETIN: TSB008_AU

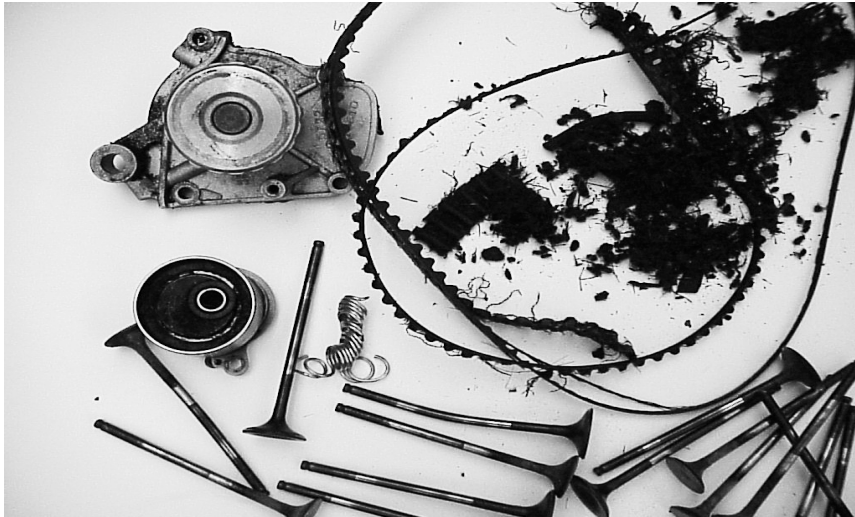
Below is the result from improper belt setup. Notice the damaged spring, this is the result of turning the crankshaft clockwise during initial setup, which is incorrect.

- Incorrect tensioner position
- Improper belt tension

- A violent correction of the tensioner position
- Damage to tensioner and/or spring and/or belt
- Improper belt tracking causing interference with other components
- Catastrophic engine damage due to timing belt and other component failure

Crankshaft must be rotated two turns **COUNTERCLOCKWISE** with locking pin in tensioner and attachment bolt loose. Not following proper installation procedures will cause:

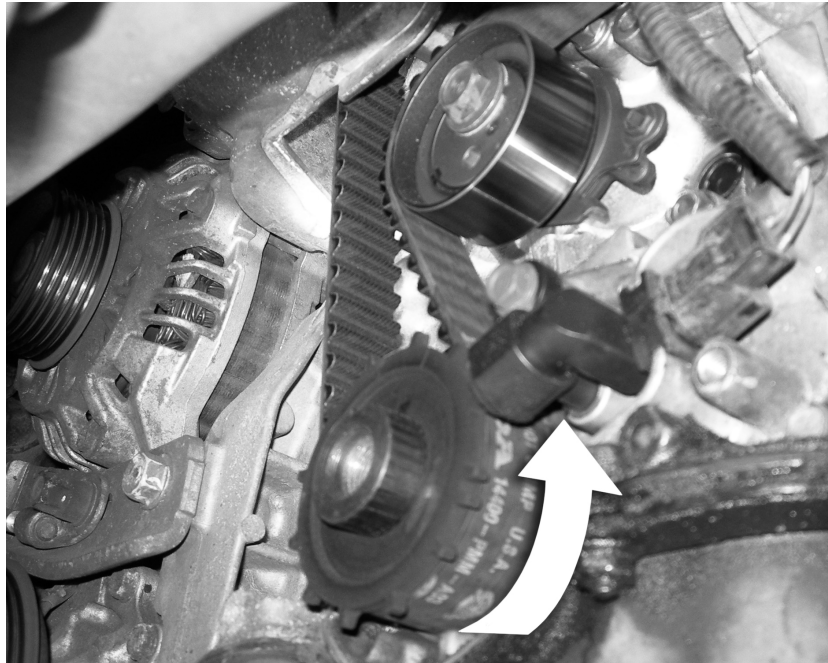
During setup attention needs to be given to the relationship of tensioner spring. The spring must be in the “UP” position which is noted on the spring rubber dampener.

Please be advised that early model year Civics may require an updated tensioner bolt. Honda upgraded the timing belt tensioner assembly in late 2002. Gates Tensioner follows the design change. During this change the OE bolt length was also changed to allow for proper thread engagement. Gates supplies the updated bolt as part of TCK312 Kits.

Verify this issue with one of the following procedures, the updated OE tensioner and bolt has been provided in this kit.

1. With tensioner fastening bolt placed through tensioner assembly – Verify there is 15mm of thread engagement.
2. Measure Bolt: Bolt length for new tensioner design provided in this kit should be 54mm in length.

(Incorrect Bolt Length Is 50.6mm).

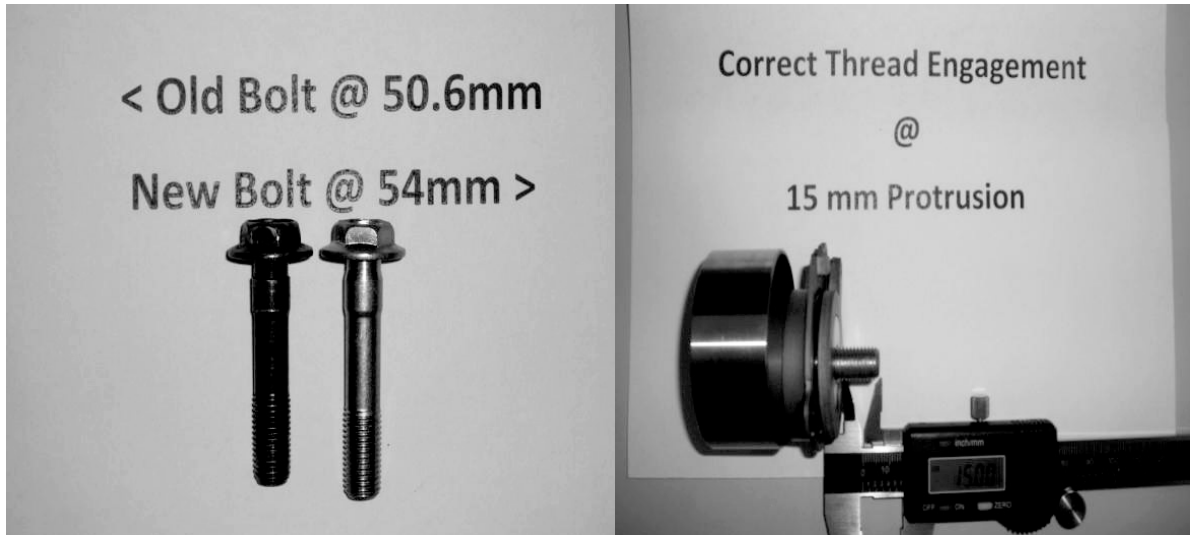
**PROPER INSTALLATION IS CRITICAL. IMPROPER INSTALLATION WILL VOID WARRANTY AND WILL MOST LIKELY RESULT IN MAJOR ENGINE DAMAGE!
CRANKSHAFTS ON THESE ENGINES ROTATE COUNTERCLOCKWISE!!!**
