# TECH NOTE

## AUTOMOTIVE – PASSENGER CAR INCORRECT ROTATION CAN LEAD TO SYSTEM FAILURE ON HOLDEN 1.6, 1.8, 2.0, 2.2 16V ENGINES

BULLETIN: TSB001\_AU

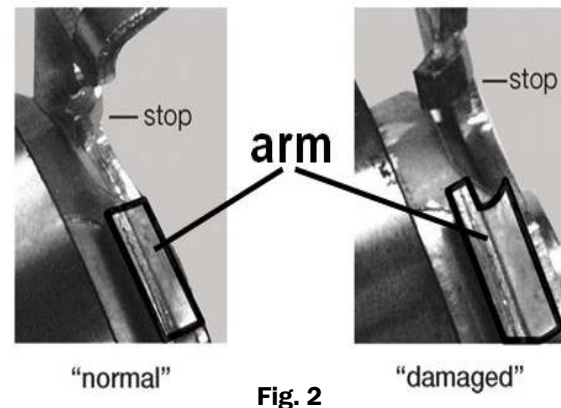
Rotating the tensioner in the wrong direction, having the allen keyhole in the wrong position to start off, not turning the engine 2 revolutions before and after setting the tension, can lead to system failure. This will cause the arm of the tensioner to hit the stop, creating a hammering noise, damaging and possibly even rupturing that part. This failure mode is very common and can easily be recognised when inspecting the edge of the arm (Fig. 4). The resulting wrong tension can cause the belt to rupture.
