# **SYNCHRONOUS BELT FAILURE ANALYSIS GUIDE**

If you're replacing your belts more than once per year, it's time to analyze your drive. From belt crimping damage to high belt installation tension to sprocket misalignment and adverse environmental conditions, this guide walks you through how to identify the reasons behind premature failure and makes recommendations on corrective and preventive measures.

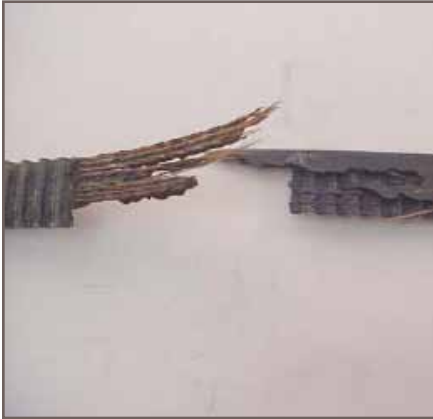
A failure that occurs when a belt reaches its ultimate tensile cord fatigue life, after running for a period of two to three years may be considered to be normal. Belt tensile failure due to cord fatigue after a long running period is considered to be ideal. Figure 1 illustrates a jagged 45-degree belt fracture that is typical of tensile cord at the end of its fatigue life.

Figure 1 – Normal fatigue failure

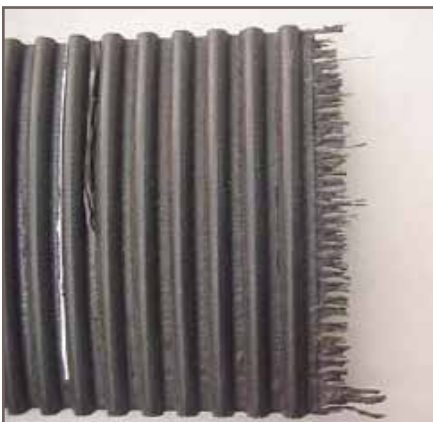
A “crimp” type belt failure often resembles a straight tensile failure as illustrated in Figure 3. A straight type of break like this may occur when belt tensile cords are bent around an excessively small diameter. A sharp bend may result in large compressive forces within the tensile members causing individual fibers to buckle or crimp, reducing the overall ultimate tensile strength of the belt. Belt crimping damage is most commonly associated with belt mishandling, inadequate belt installation tension, sub-minimal sprocket diameters, and/or entry of foreign objects within the belt drive.

Figure 3 – Crimp failure

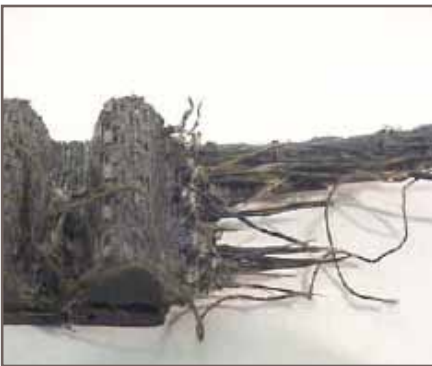
Severe shock loads can result in belt tensile breaks with a ragged and uneven appearance as illustrated in Figure 4. The particular belt teeth engaged in the sprocket at the instant of the shock load may also develop root cracks and/or exhibit tooth shear. If the shock load occurred only once, or was cyclical and repetitious at one specific location around the belt, the remaining belt teeth may appear normal. Figure 5 illustrates how root cracks caused by shock loading can propagate through the teeth. Cracks forming at the tooth roots sometimes move towards the tooth tips. Teeth containing multiple cracks may then shear, leaving only a portion of the tooth behind.

Figure 4 – Typical shock load failure

The shock loads generated by the driven equipment may be an inherent part of system operation or may result from an occasional harsh condition such as jamming. If the drive shock loads cannot be eliminated, the belt tensile strength may need to be increased or the synchronous belt drive replaced with a more forgiving V-belt drive system capable of intermittent slip.

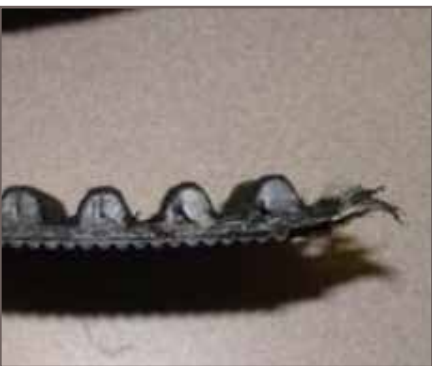
Figure 5 – Tooth root crack propagation

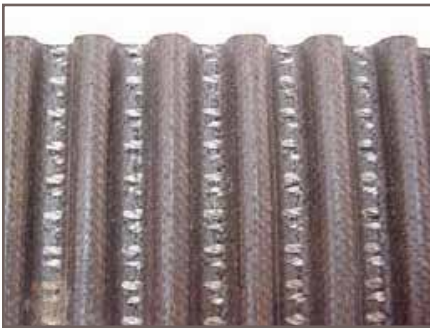
Figure 7 - Excessive land area wear

Applying excessive installation tension to a synchronous belt may result in belt tooth shear or even a tensile break. Many belts that have been excessively tensioned show visible signs that sprockets have worn the belt land areas. Figure 6 illustrates a belt with crushed land areas and a crack that formed at the root of the belt tooth. A root crack will often propagate down to the tensile member and travel to the next root crack. Individual belt teeth will then separate from the body of the belt and often fall off. Figure 7 illustrates a belt that had been over tensioned on large sprockets. High belt land pressures caused excessive belt land area wear, ultimately revealing individual tensile cords. In order to prevent belt wear problems like these, proper belt installation tension levels must be determined and set accurately.

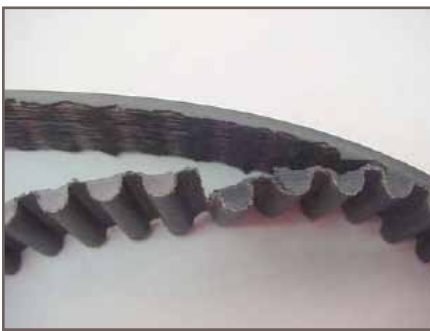
Figure 8 – Tooth separation failure

Applying insufficient installation tension to belts operating on moderately to heavily loaded drive systems may also result in premature failures. A common belt failure mode resulting from insufficient belt installation tension is referred to as tooth rotation. Belt tooth rotation can occur as belt teeth climb out of their respective sprocket grooves (self tensioning) and drive loads are no longer applied at their roots. Drive loads applied further down the belt tooth flanks cause the belt teeth to bend (like a diving board) and “rotate.” Belt tooth rotation can result in rubber tearing at the base of the belt teeth along the tensile member. As rubber tearing propagates, belt teeth often begin to separate from the belt body in strips, as illustrated in Figure 8. Failures due to excessive tooth rotation may resemble failures caused by insufficient rubber adhesion to the tensile cords. Unlike tooth rotation failures, failures from insufficient rubber adhesion leave the exposed tensile members clean where the belt teeth were once located.

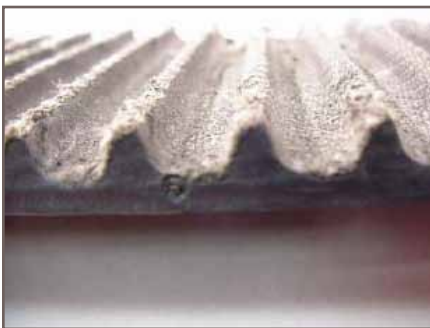
Figure 9 – Excessive tooth wear

As belt teeth climb out of their respective sprocket grooves to self tension, belt ratcheting or tooth jumping may occur before rubber tearing and belt tooth separation occurs. Belt tensile cord damage resulting from ratcheting can cause premature belt tensile failures. These tensile failures may resemble crimp type breaks (straight and clean) as well as shock load type breaks (jagged and angled). If belt ratcheting does not occur and belts continue to operate while self tensioning, excessive belt tooth wear often occurs. This tooth wear is referred to as “hook wear” and results from improper belt tooth meshing with the sprockets, as shown in Figure 9. Hook wear type belt failures result from

Increasing belt installation tension levels generally prevents premature belt failures due to tooth rotation and hook wear. If increasing the belt installation tension level does not prevent this type of failure, the drive structure may not be rigid enough to prevent deflection. Added structural support may be necessary to improve belt performance. If it is not practical to increase belt installation tension levels, increasing the sprocket diameters will allow higher drive loads to be transmitted with less belt tension.

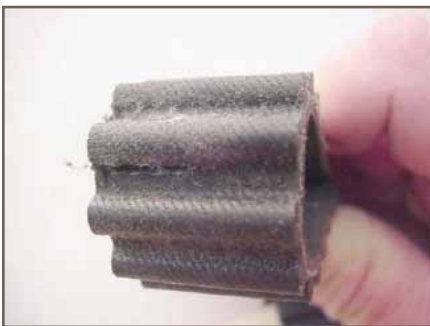
Figure 11 - Uneven belt wear

Belts operating on drives with angular shaft misalignment or tapered sprockets often exhibit an uneven wear pattern across the belt tooth flanks and uneven compaction in the land areas (in between belt teeth) due to the uneven application of load to the belt. Belt failures often occur from tooth root cracks or tears initiating on the side of the belt that is carrying the highest tension and propagating across the belt width, ultimately resulting in tooth shear. One edge of the belt may also show significant wear due to high tracking force and may even roll up or attempt to climb the sprocket flange(s). Figure 10 shows extreme belt edge wear from a high tracking force.

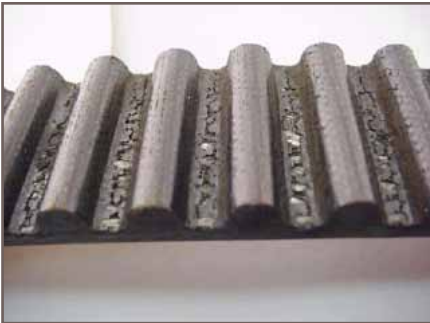
Figure 13 - Land disintegration

Curvilinear (HTD and GT) belts operating on sub-minimal sprocket diameters usually fail by land disintegration, illustrated in Figure 13, and tensile breaks. Trapezoidal (XL, L, H) belts will usually fail by tooth root cracks and tooth shear; however, tensile breaks are not uncommon.

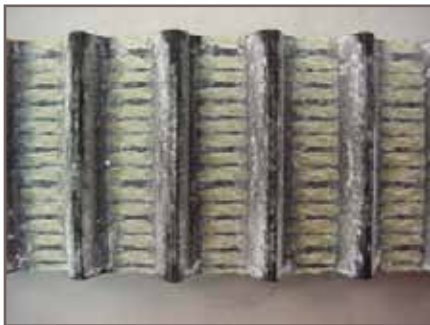
Figure 16 - Extreme wear from abrasion

Belts operating in abrasive atmospheres on applications like foundry shakers, taconite processing equipment, and phosphate mining conveyors often exhibit a high degree of belt land and tooth flank wear. Worn areas frequently have a polished appearance. Figure 16 illustrates a severely worn Gates Poly Chain® GT®2 belt that ran in a highly abrasive environment. Sprocket wear is generally rapid in abrasive environments; therefore, sprockets should be replaced along with belts. To extend the life of belts and sprockets, a sealed guard that is pressurized with clean air can be installed to help keep out abrasive dust and contaminants.

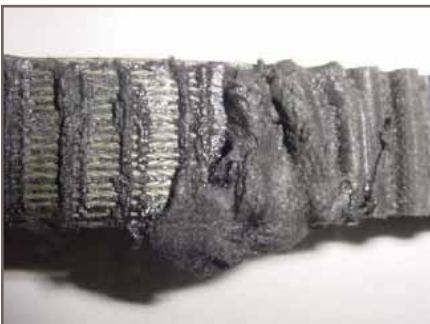
Figure 18 - Melting from high temperature operation, polyurethane

The body material used in urethane belts such as Poly Chain® GT® Carbon® belts is thermoplastic, meaning it has a melting point. When subjected to environmental temperatures in excess of 185°F, the teeth may begin to soften and deform. In addition, the tensile cord to urethane adhesion loses its integrity. Figure 18 illustrates a Poly Chain® GT®2

belt that was exposed to a high environmental temperature.

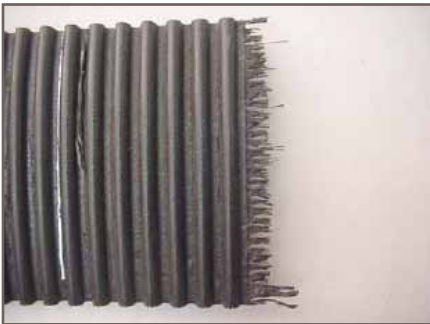
Figure 20 - Crimp failure due to debris

The introduction of foreign objects between a belt and sprocket often damages both belt teeth and tensile cords. Tensile cords often fracture internally (see Figure 19) or fail later due to crimping, as shown in Figure 20. Once a portion of the tensile cords have fractured, the remaining tensile strength of the belt has been reduced considerably. This often results in a dramatic reduction in belt life. If belt damage from debris is noticeable, the belt should be replaced and the sprockets checked for damage. Damaged sprockets should also be replaced.
