TECH NOTE

AUTOMOTIVE – SYNCHRONOUS BELT DRIVE SYSTEM

CAUTION REQUIRED TO CORRECTLY INSTALL THE TENSIONER ASSEMBLY AND AVOID PREMATURE FAILURE

BULLETIN: TSB017_AU

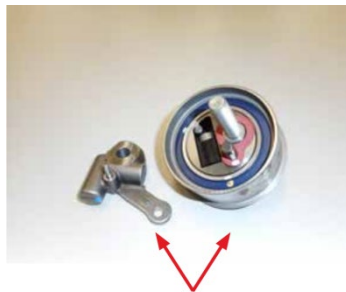
- The hydraulic actuator that sits on the tensioner pulley is not fixed and can easily be dislodged from its correct, ready to be installed, packaged state. This can occur from dropping or fumbling the unit during installation. **Keeping the rubber sleeve over the bolt threads until the very moment that the tensioner is to be installed** can help in preventing the hydraulic mechanism from separating from the tensioner pulley.
- **DO NOT remove the pin before installation.** Removing the pin before it's required will cause the hydraulic actuator to separate or partially separate from the pulley. This will cause the piston of the actuator to either completely exit the hydraulic chamber or fully extend to the end of its stroke suddenly.

- **Do not use** if hydraulic actuator has become separated from the tensioner pulley. There is an internal spring that will also need to be repositioned which can lead to premature failure if not done precisely.

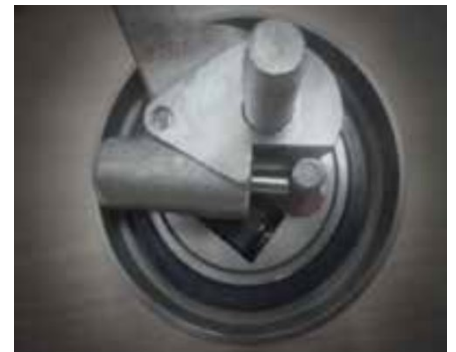
- Install the tensioner to the engine.
- Rotate the tensioner with a force of 39NM or less in an anticlockwise direction using an Allen wrench.
- Then turn it back slowly.
- Repeat this procedure several times.
- Verify that the piston has resistance when it is in the most projected position. If there is no resistance, repeat the above procedure.

BLEED-OUT PROCEDURE:

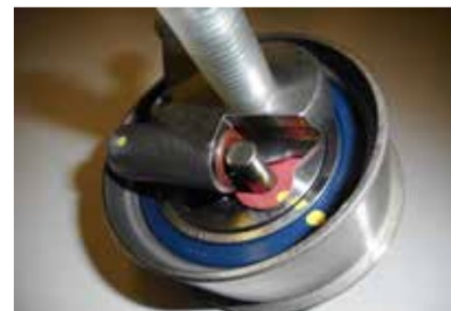
-
- **Do not remove** set pin before installation of the belt and idler. Also ensure the tensioner bolts are tightened to specifications before releasing the pin. Refer to the OEM recommended installation procedure.
 - **T43009 Tensioner.** This tensioner unit is available separately from Gates.
 - If the piston has expelled before installation, it is likely that a bleed-out of air from the pressure chamber is required.

This is the correct state of the tensioner before installation. **DO NOT** install if the tensioner assembly does not resemble the image above.
