TECH NOTE

LOOSENING THE WATER PUMP BEFORE BELT INSTALLATION IS VITAL TO CORRECT TENSION ON HOLDEN & DAEWOO 16V PETROL ENGINES

BULLETIN: TSB003_AU

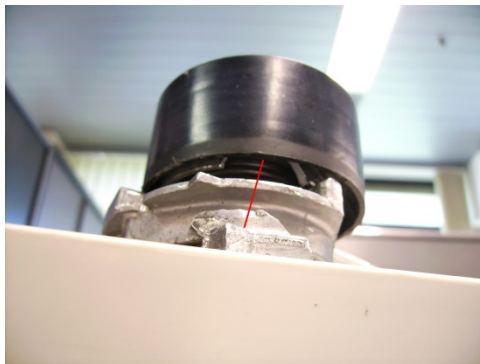
Fig. 2

If the tensioner bolt is not loosened, the pointer of the tensioner will hit the cold stop violently. This could seriously damage the pointer, resulting in a rupture (later on). Proceeding this way, in order to be able to install the new belt, the pointer of the tensioner has to be pushed back. When trying this with a screwdriver, you risk that the screwdriver will slip off the pointer (because of the high spring tension) which will again hit the cold stop. Fig. 3 shows where the pointer is situated on a good tensioner (in its rest position).

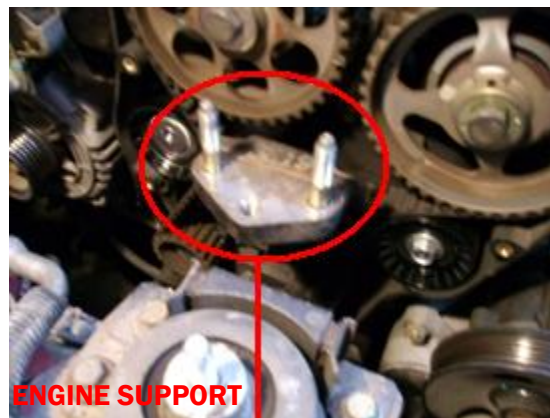
Fig. 4

In order to make access to the drive easier, it is recommended to remove the engine support (Fig. 4).

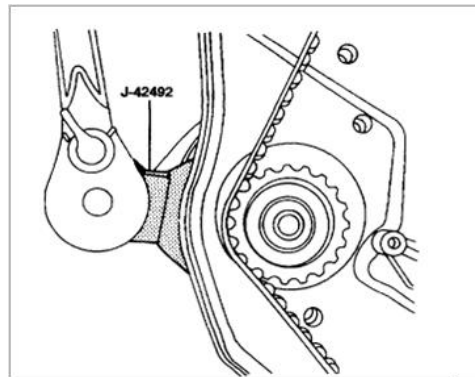
Fig. 5

1. Remove auxiliary belt crankshaft pulley, re-install bolt
2. Put engine at TDC: rotate the crankshaft clockwise until the timing mark on the crankshaft gear is aligned with the notch at the bottom of the rear timing belt cover, and align the timing marks on the camshaft gears (Fig 1). Ensure camshaft gears are locked
3. Slightly loosen the bolts of the water pump
4. Rotate water pump anticlockwise, using special adjustment tool (Gates: GAT V501A or OE: J-42492 or KM-421-A), to release tension on the belt (Fig. 5)
5. Remove the timing belt, tensioner and idler.

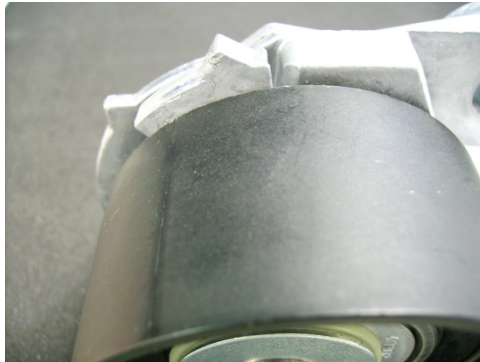
Fig. 6 - View From Front

1. Install a new tensioner and idler, and fit the new belt (anticlockwise, starting from crankshaft). Use kit TCK310 or TCKWP310 (includes water pump).
2. Adjust tensioner pointer up to the notch in the tensioner back plate - close to the right hand stop - by rotating the water pump gently clockwise (Fig. 6, 7 and 8).
3. Tighten the water pump bolts

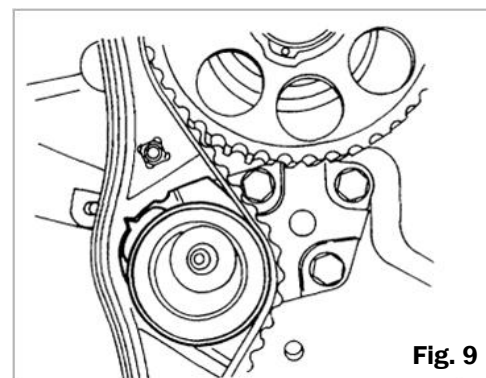
Fig. 9

4. Rotate the engine two full revolutions clockwise (by rotating crankshaft) until TDC.
5. Slightly loosen the bolts of the water pump
6. Bring tensioner pointer in line with the pointer on the tensioner back-plate by rotating the water pump anticlockwise, with special adjustment tool. (Fig. 9)
7. Tighten the water pump bolts.
8. Re-install engine support
9. Re-install the removed auxiliary belt crankshaft pulley

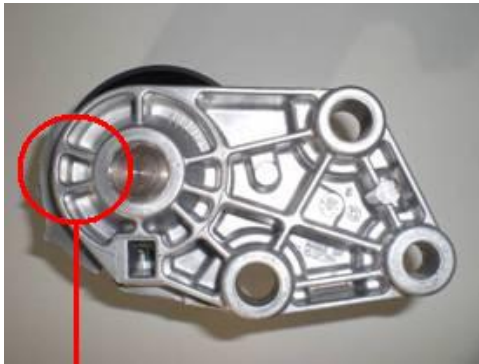
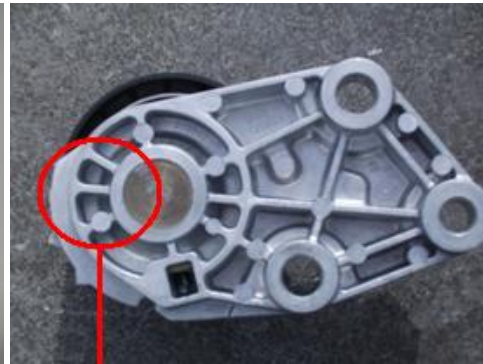
In addition, watch out for counterfeit tensioners which can be widespread in certain markets (Fig.10 and 11 are OE, Fig. 12 is counterfeit).
