GATES WATER PUMPS

**THE HIGHEST QUALITY
STANDARDS IN THE INDUSTRY
AND THE HIGHEST COVERAGE**

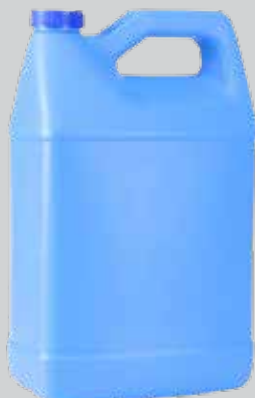
50/50 PREDILUTED ANTIFREEZE & COOLANT DO NOT ADD WATER

Prediluted Antifreeze & Coolant can be used to top off cooling systems filled with any automotive antifreeze. However, to realise the 150,000 miles or 5 years of maximum cooling system protection, a complete cooling system flush and fill is required. *Always follow vehicle's owner's manual for top-off requirements and specified maintenance.

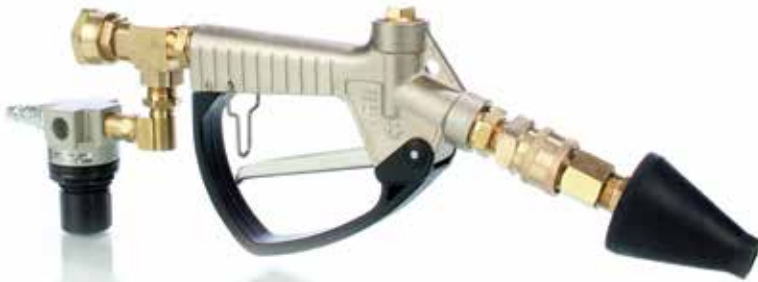
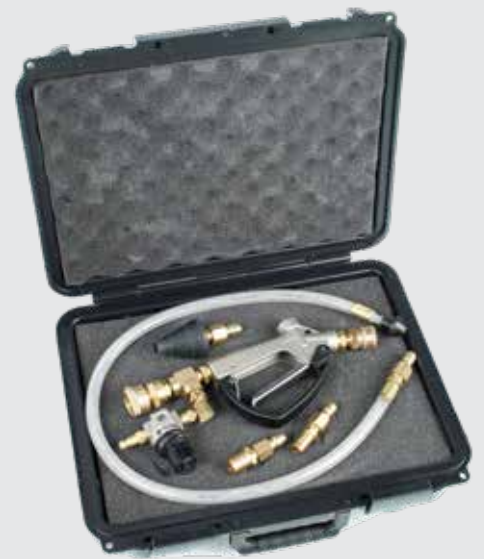
POWERCLEAN™ FLUSH TOOL KIT (Part #: 91002) INCLUDES:

- Pulsating Gun Assembly with Pre-set Regulator
- Water Line Backflow Preventer
- Large Rubber Tip for Radiator Necks and Direct Flushing of the Engine Block
- Small Rubber Tip on Whip Hose for Direct Access to Heater Core Tube Stubs
- 5/8" and 3/4" Heater Hose Barbs for Flushing Heater Cores or Engine Blocks
- Durable Protective Storage Case with Room for Additional Items

- Performs necessary "complete flush" when replacing water pump.
- Thoroughly cleans contaminated systems including mixed coolants, improper coolant/water mix, and broken down rust inhibitor packages.
- Cleans system to ensure water pump seal isn't compromised resulting in warranty or customer satisfaction issues.
- Excellent revenue stream source as evidenced by professionals currently utilising POWERCLEAN™ on every water pump installation.

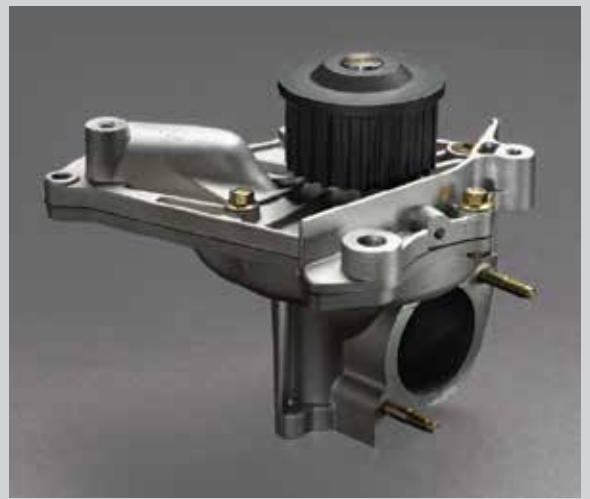
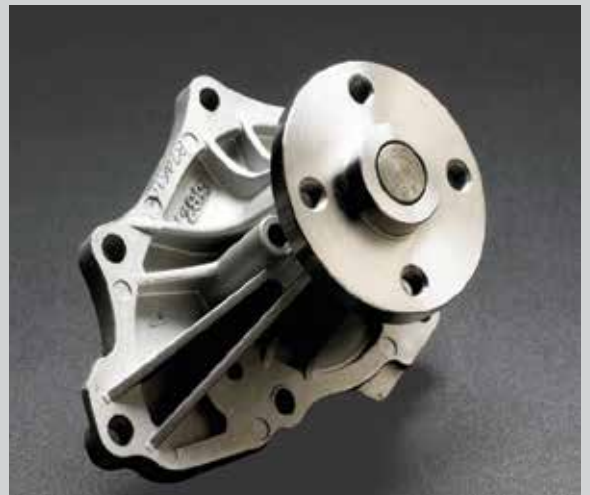
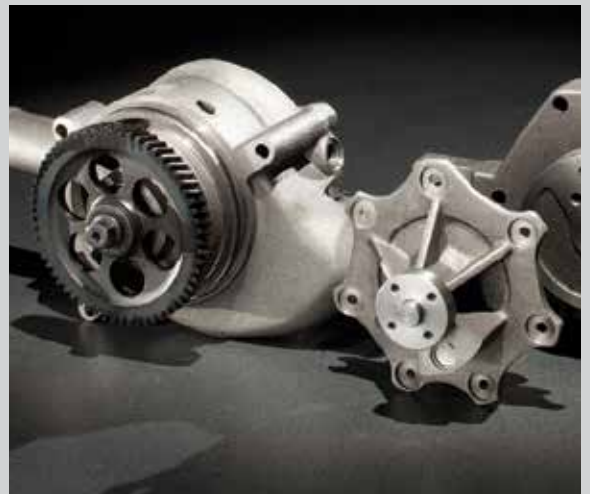
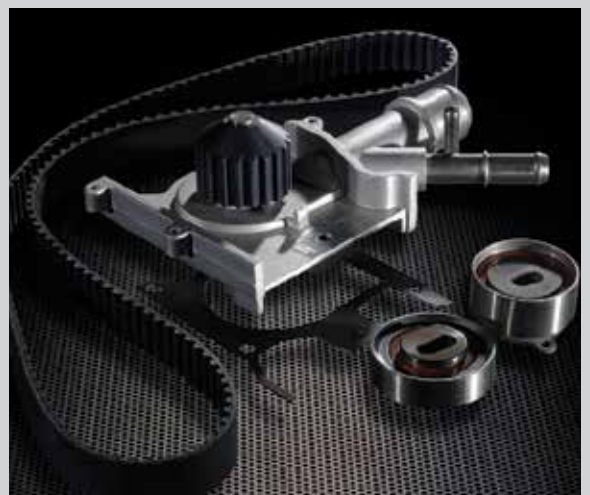
PRE-ASSEMBLED WATER PUMPS AND HOUSINGS

- Easy one-unit installation
- Ensures trouble-free operation and reduced comebacks

ELECTRIC WATER PUMPS

- OE replacement ensures an exact fit and easy installation
- Main engine electric water pumps come with gaskets or rubber seals to eliminate leaks.
- Includes coverage of hybrid vehicles Toyota Prius and Toyota Camry

HEAVY DUTY WATER PUMPS MANUFACTURED TO ISO/TS STANDARDS

- Designed to handle rugged fleet applications
- 100% fully-tested unitised bearings/seals
- Computer-machined surfaces for proper fit/sealing

METAL IMPELLERS

- Where standard on OE pumps, Gates utilises metal gaskets which eliminate the need for RTV or silicone and save installation time.

METAL GASKETS

- Where standard on OE pumps, Gates utilises metal gaskets which eliminate the need for RTV or silicone and save installation time
