## TECH NOTE

### AUTOMOTIVE – ACCESSORY BELT DRIVE SYSTEM

**BULLETIN:** TSB024\_AU

## INSTALLATION INSTRUCTIONS FOR BELT OAP7144

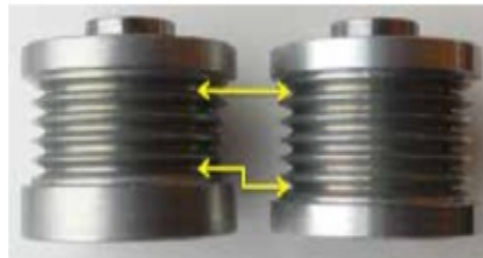
**Fig. 1**

On certain Opel/Vauxhall/ Holden engines (codes: A14NEL, A14NET, A14XEL, A14XER) the belts may have 5 or 6 ribs while the pulleys may have 5 or 6 grooves, depending on the manufacturing date of the car. Gates recommends replacement of a 5 groove OAP (Fig.1 left side) with the 6-grooved OAP7144 (Fig. 1 right side).

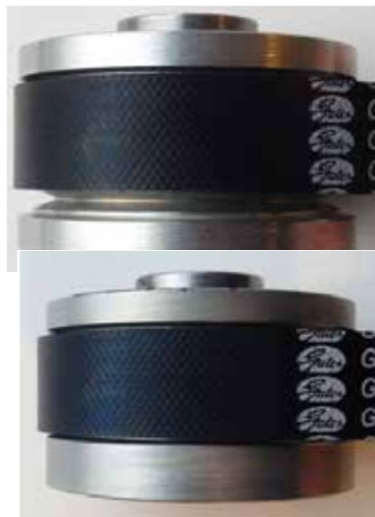
**Fig. 3**

If the belt is not placed correctly on the OAP like this, severe misalignment occurs, which may cause premature failure. Fig.3 shows an OAP with 5 grooves that must be replaced by the 6-grooved OAP7144.

If a belt with 5 ribs must be installed onto OAP7144 (Fig. 2), the outer groove (away from the engine) must be left open.
