TECH NOTE

5PK MICRO-V® AT BELT CHANGE ON RENAULT ENGINES

BULLETIN: TSB013_AU

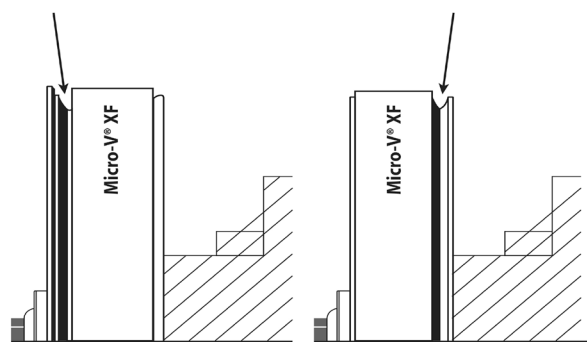
Fig. 1

As these 5PK belts run in the initially installed 6 groove pulleys, it is important to install the belt in the correct pulley grooves. This is because there have been cases where incorrect belt placement caused the multi ribbed belt to be destroyed, resulting in parts entering into the timing belt drives and causing considerable damage to the engine.

- Without air conditioning:
 - Power steering pump is belt driven: belt has to be on the inside of the pulleys (fig. 1)
 - Power steering pump is electrically driven (not included in the belt drive): belt has to be on the outside of the pulleys (fig. 2)
- With air conditioning:
 - Belt has to be on the outside of the pulleys (fig. 2)

- Belt has to be on the outside of the pulleys (fig. 2)

Please note the correct belt installation:
